# OPERATION PLUMB BOB

NEVADA TEST SITE  
MAY-OCTOBER 1957

Project 30.2

RESPONSE OF DUAL-PURPOSE  
REINFORCED-CONCRETE MASS SHELTER

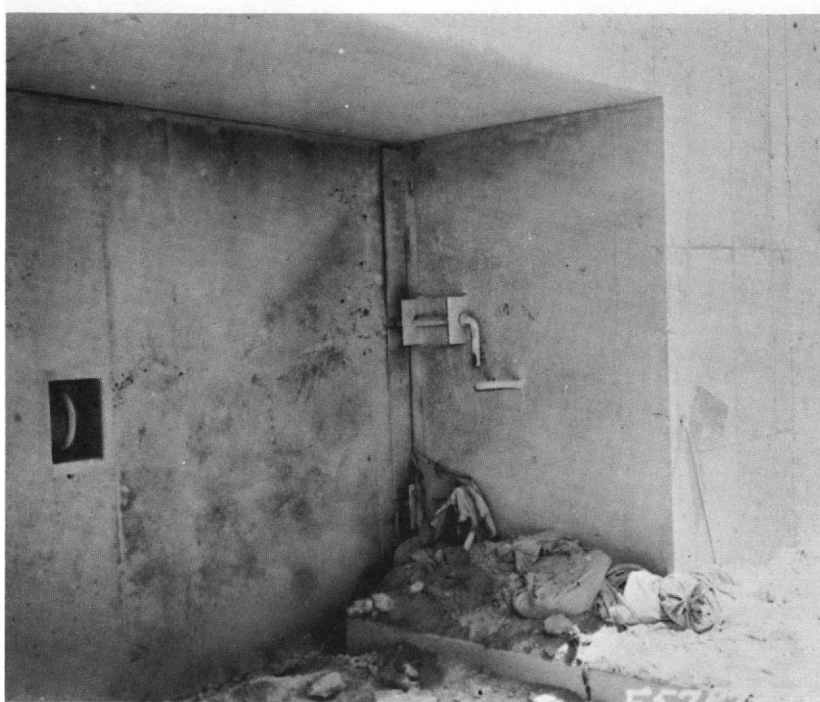
The door withstood the blast without any evidence of shifting or disalignment. Locking bolts in the door were intact and retracted freely (Fig. 3.8). The  $\frac{1}{4}$ -in. cover-plate angle at the exposed top edge of the door frame was separated from the concrete at several locations. The 12-in. steel guide plate on the 4.5-ft wall was not made continuous as intended and was torn back by the door during the postshot opening (Fig. 3.9). The door wheels were not damaged, and the track was not displaced (Fig. 3.10). The door and end pilaster were partially blackened by thermal radiation.

Fig. 3.8—View of door showing locking bolts (postshot).

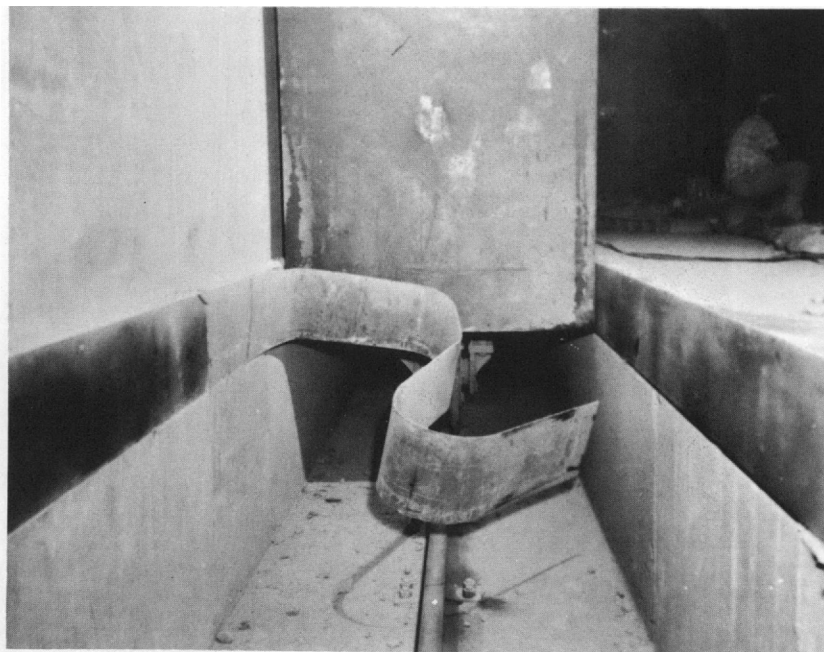
Fig. 3.9—Torn guide plate before removal to allow opening of door (postshot).

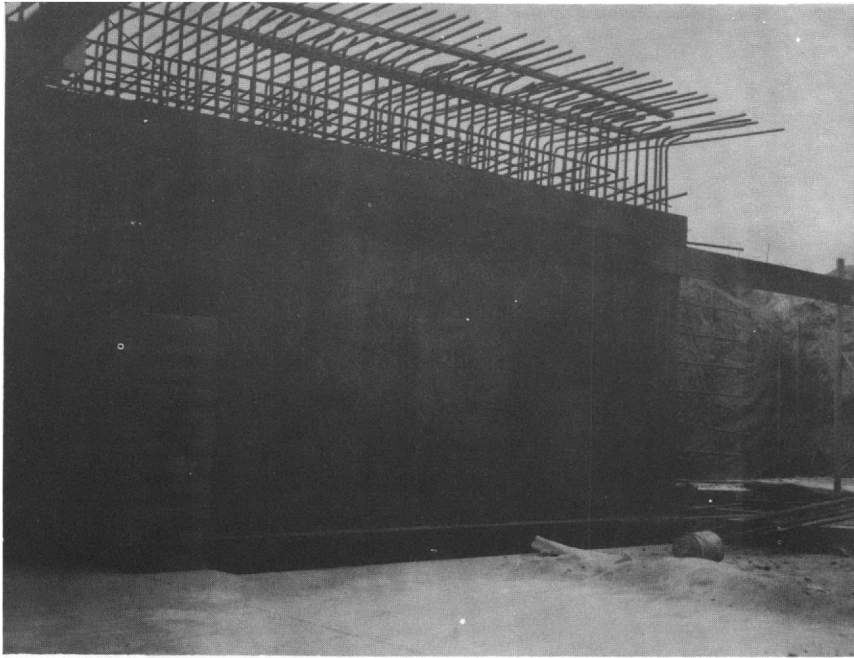
The face plates for the rolling door and all corner protection angles were poured integral with the various concrete members they framed into. The face plates were not made continuous the entire length of the door pit. This deviation from the design drawings caused some postshot door-operating difficulty.

Fig. B.9—Guide plates and bumper for rolling door.

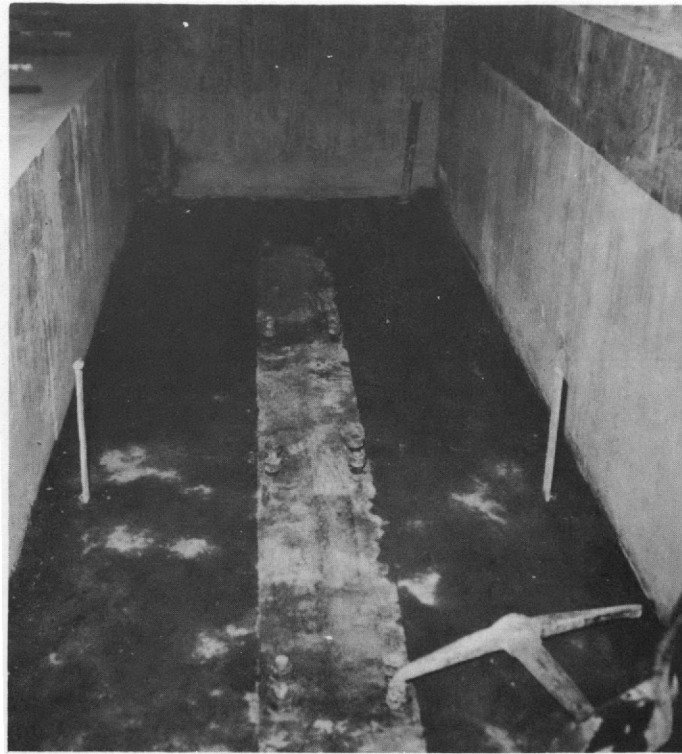
Fig. B.31—Rolling-door pit before installation of rail.

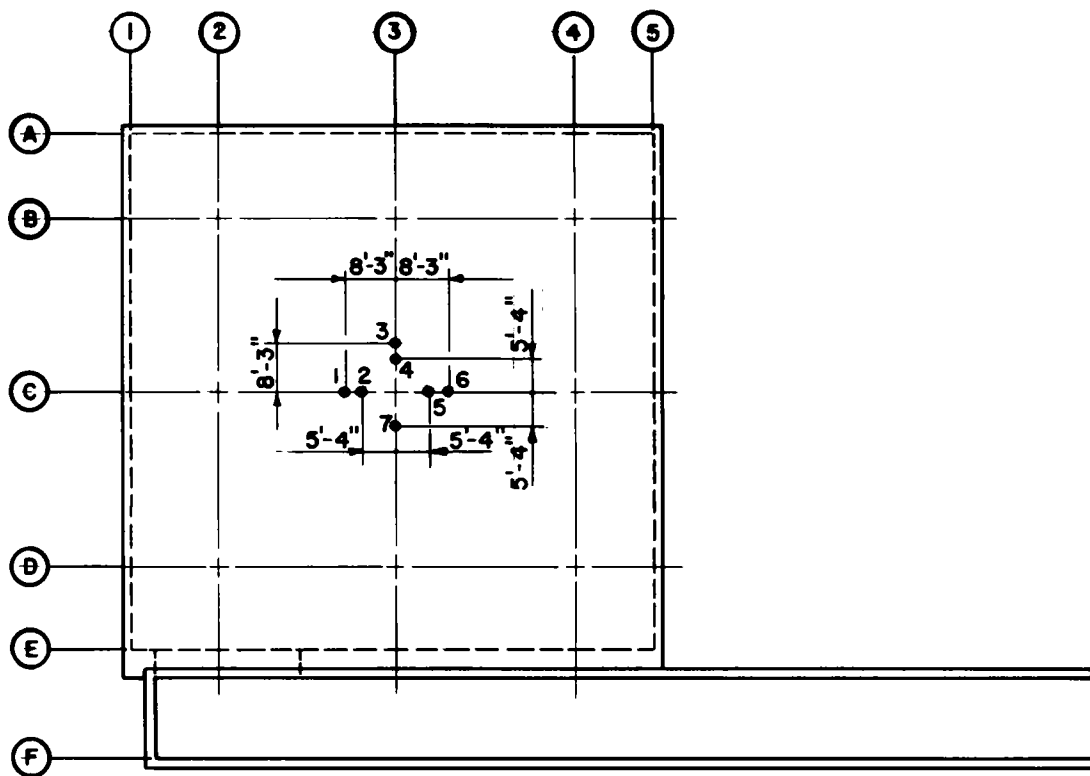
Fig. B.33—Location of postshot core holes in roof slab.

Crosshatched area indicates section of core tested.

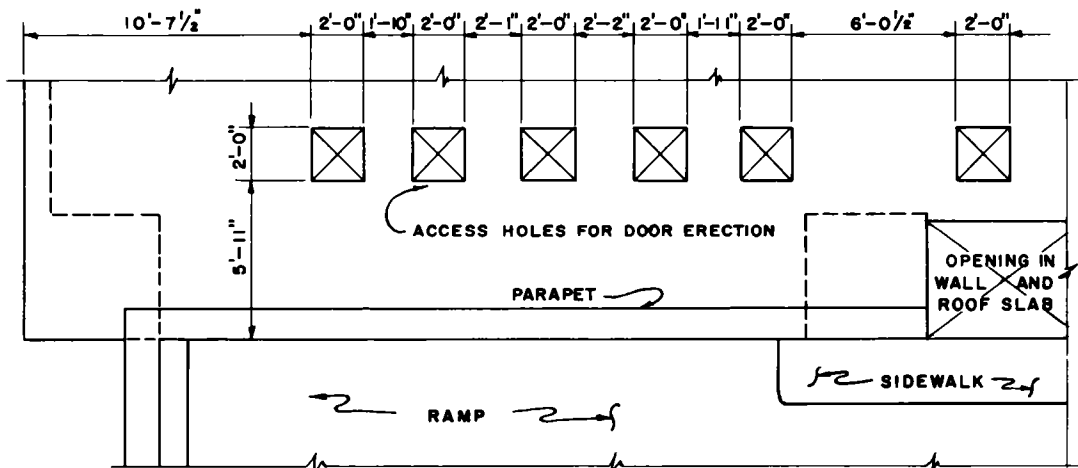
NOTE: REINFORCEMENT THROUGH HOLES WAS CUT OUT, AND THEN WELDED BACK INTO PLACE UPON COMPLETION OF DOOR ERECTION.

Fig. B.38 — Access holes for door erection.

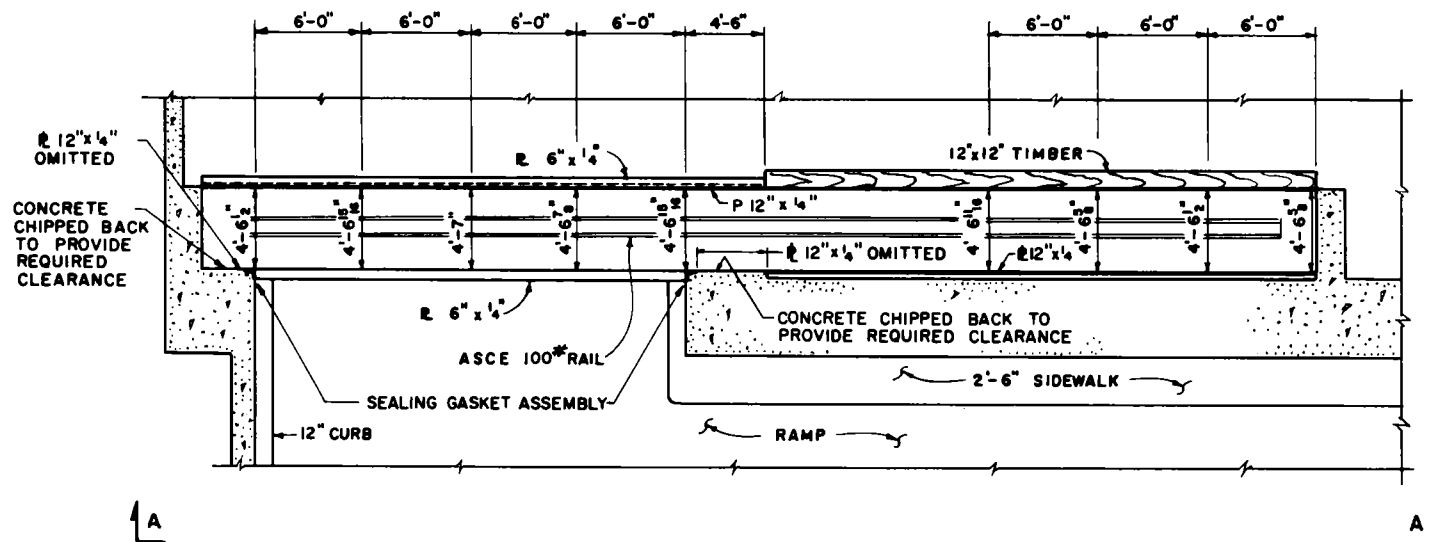
1. HORIZONTAL PIT DIMENSION SHOULD BE 4'-6 1/4"
2. DOOR NOT SHOWN
3. MEASUREMENTS TAKEN AT FLOOR LEVEL

Fig. B.39 — Plan of garage rolling-door pit.
